PRE-CERCLIS SITE SCREENING REPORT

M. Holtzman Metal Co. Site
St. Louis, Missouri

August 31, 2006

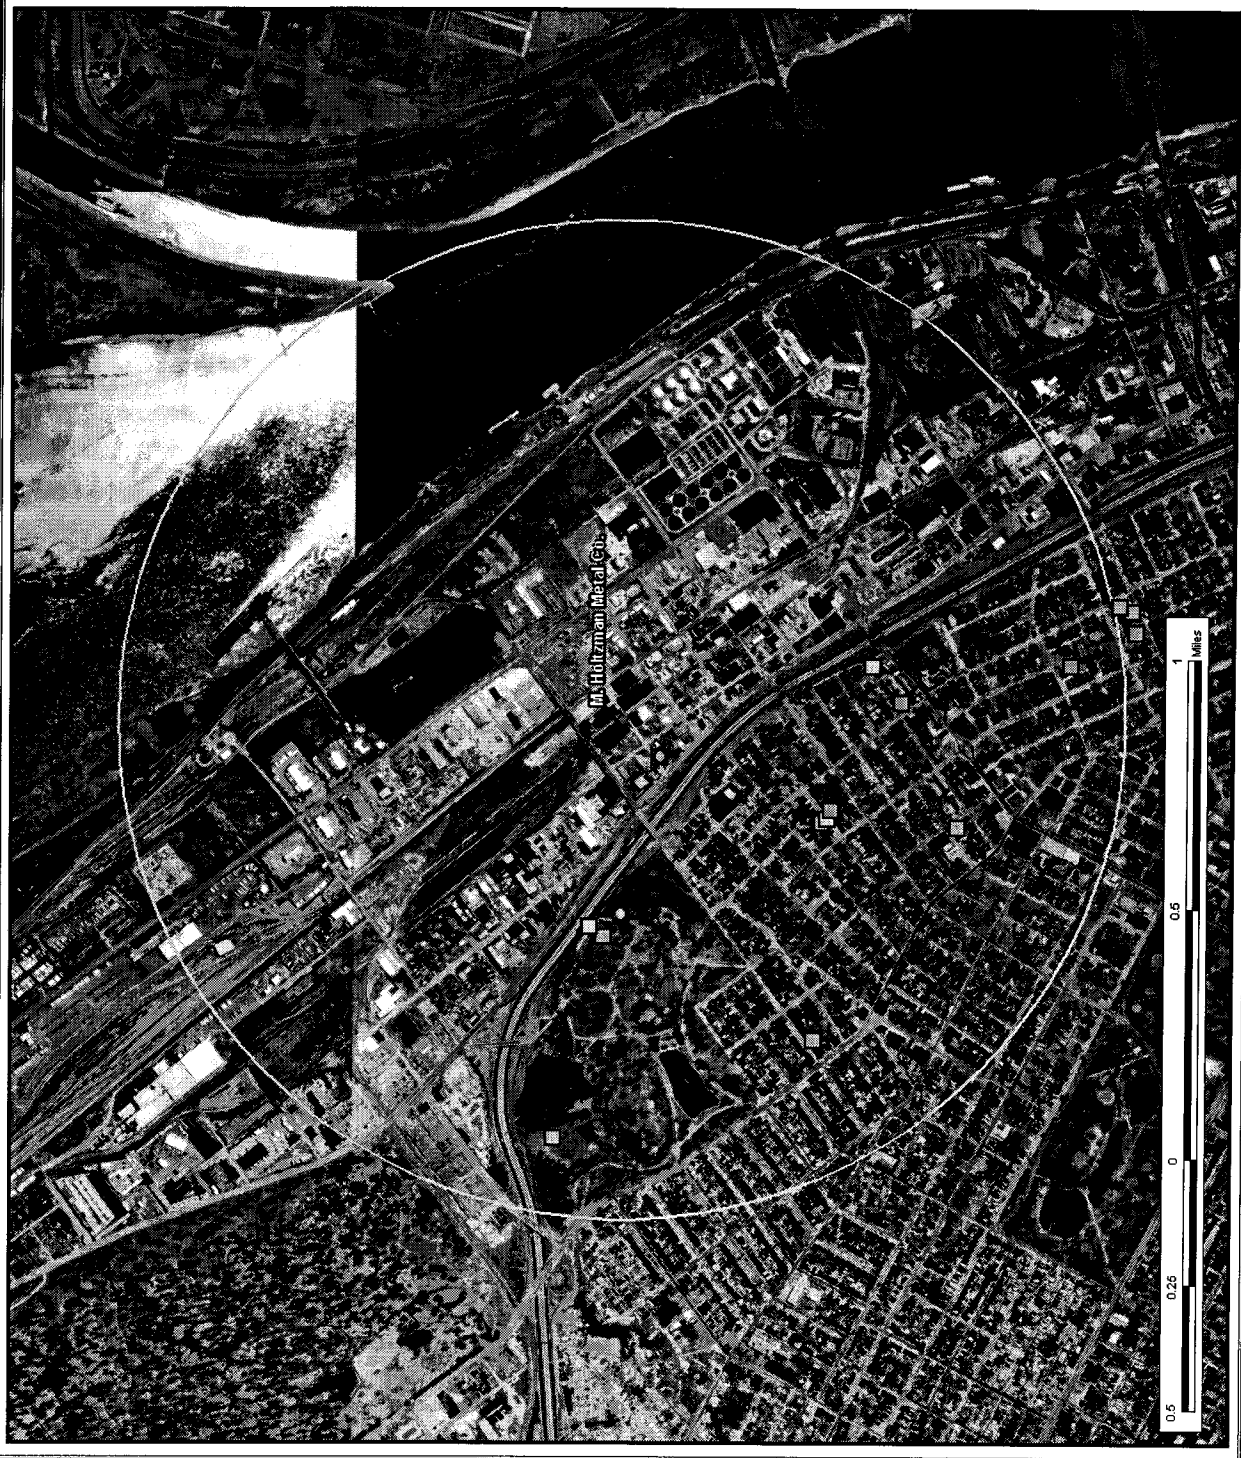
Figure 1

M. Holtzman Metal Co.
St. Louis City, MO

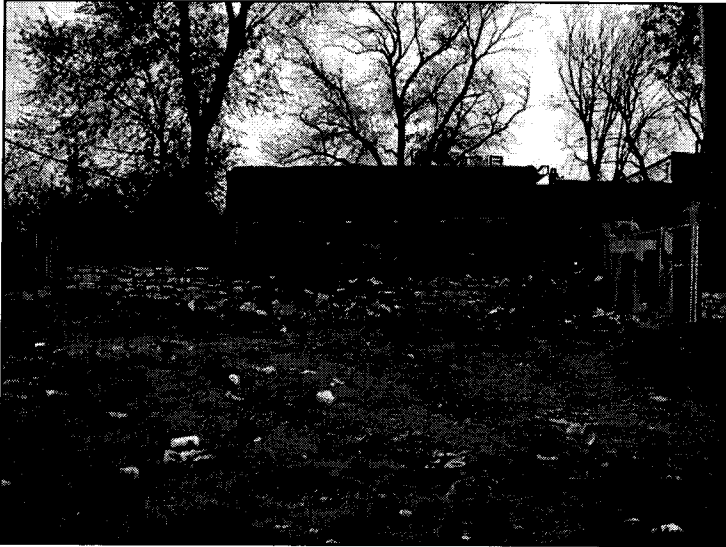
Photograph 4

| TABLE 2. XRF RESULTS FOR SOIL SAMPLES COLLECTED NOVEMBER 16 AND 17, 2004 M. HOLTZMAN METAL CO., ST. LOUIS, MISSOURI | | | | |
|--|---|---|---|---|
| 614 Withers | HWP040039 | HLOT01V01SB01 | SB | 350.7 |
| | HWP040040 | HLOT01V01SS01 | SS | 375.1 |

614 Withers, Sample location 1. View
looking southeast from Withers St.

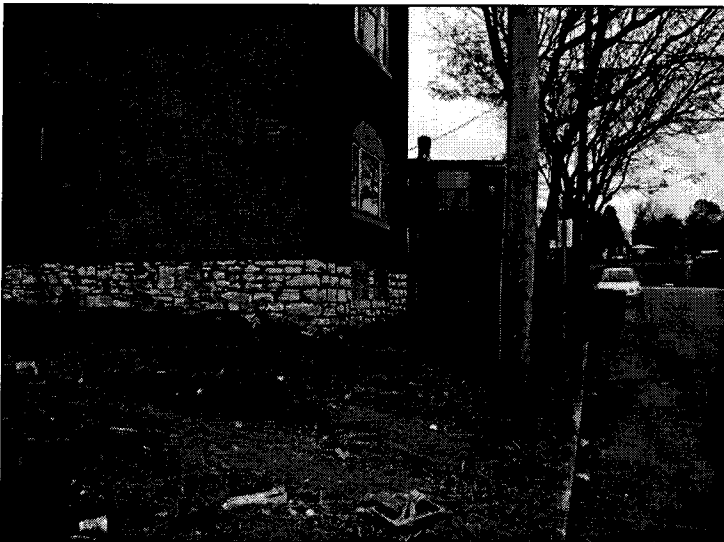
Photograph 5

614 Withers, Sample location 1. View
looking south along Withers St.

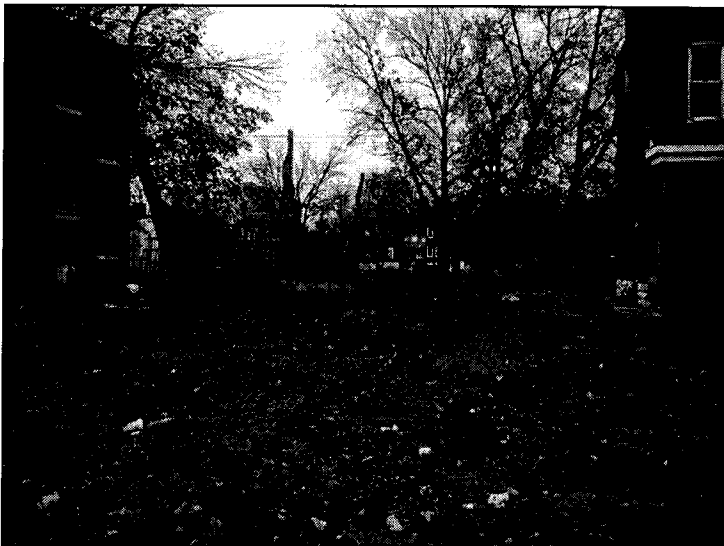
Photograph 6

| TABLE 2. XRF RESULTS FOR SOIL SAMPLES COLLECTED NOVEMBER 16 AND 17, 2004 M. HOLTZMAN METAL CO., ST. LOUIS, MISSOURI | | | | |
|--|---|---|---|---|
| 2140 Adelaide | HWP040041 | HLOT02V01SS02 | SS | 123.6 |

2140 Adelaide, Sample location 2. View
looking southeast from Adelaide St.

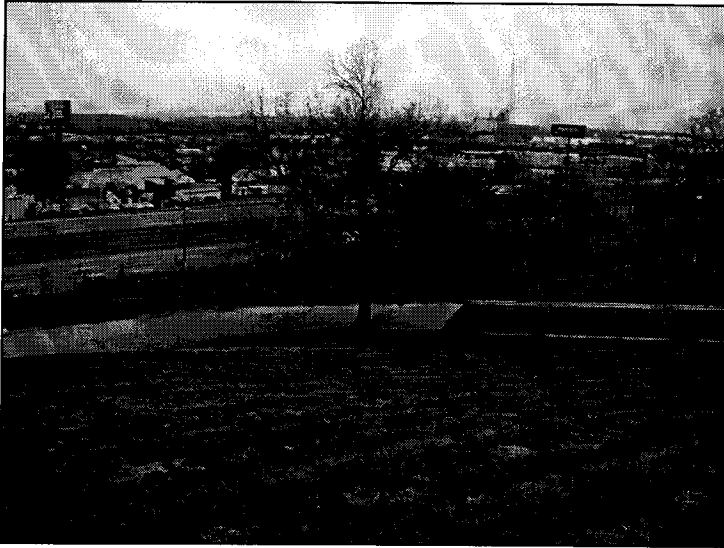
Photograph 7

O'Fallon Park, Sample location 3. View
looking east towards Interstate 70.

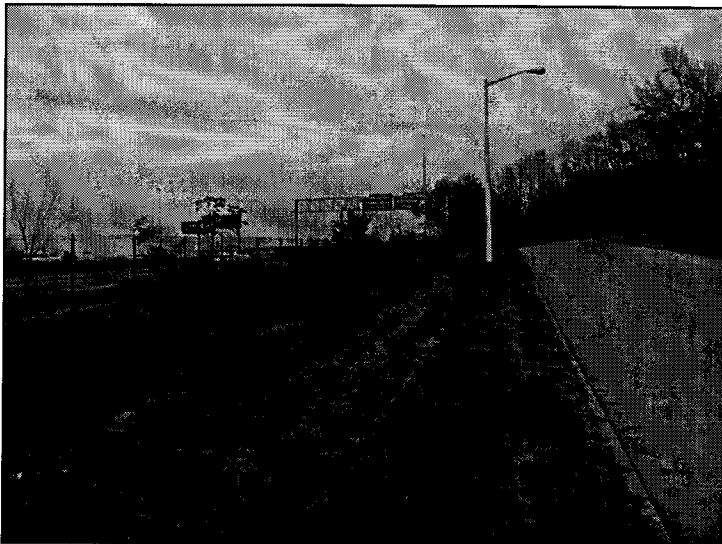
Photograph 8

Lead concentrations for sampling locations within one mile of the site ranged from 26 ppm to 558 ppm. Of the ten locations sampled, three locations contained lead in the surface soils above the EPA PRG of 400 ppm lead: a roadway near a vacant lot (558 ppm lead), a vacant lot (435 ppm), and a roadway in a park (416 ppm).

| TABLE 2. XRF RESULTS FOR SOIL SAMPLES COLLECTED NOVEMBER 16 AND 17, 2004 M. HOLTZMAN METAL CO., ST. LOUIS, MISSOURI | | | | |
|--|---|---|---|---|
| | HWP040048 | HLOT03P04SS06 | SS | 415.7 |

O'Fallon Park, Sample location 3. View
looking southeast along roadway sample
unit.

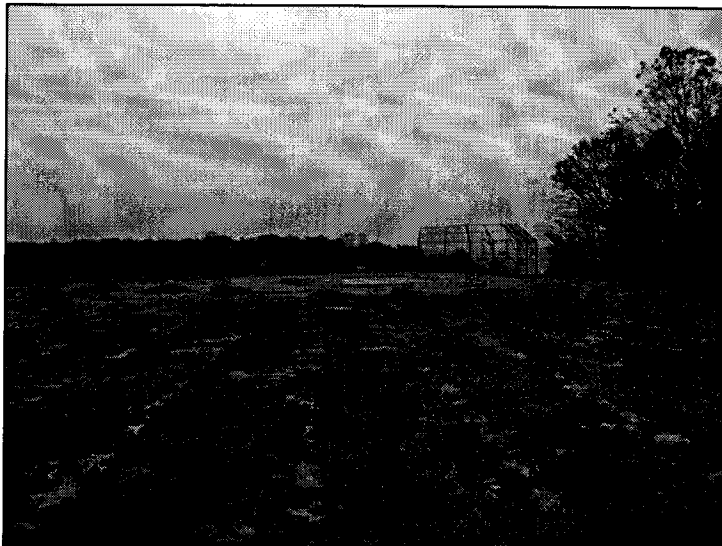
Photograph 9

O'Fallon Park, Sample location 3. View
looking north towards ballfield.

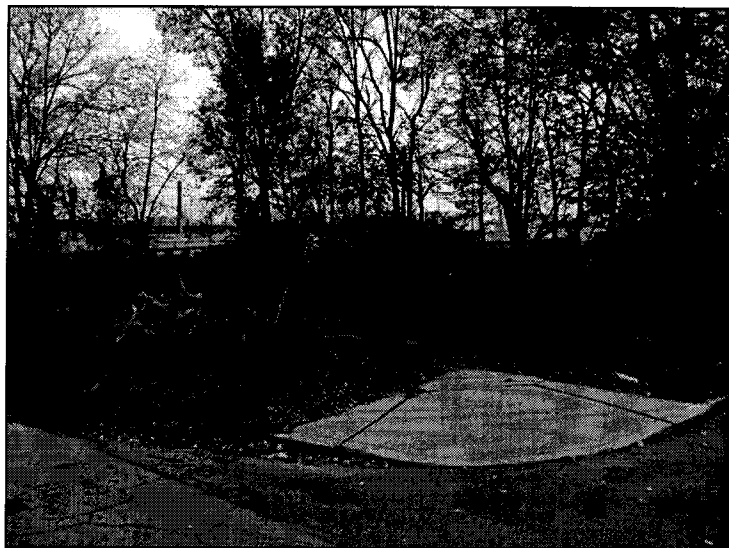
Photograph 12

| TABLE 2. XRF RESULTS FOR SOIL SAMPLES COLLECTED NOVEMBER 16 AND 17, 2004 M. HOLTZMAN METAL CO., ST. LOUIS, MISSOURI | | | | |
|--|---|---|---|---|
| 4616 Von Phul St. | HWP040053 | HLOT06V01SS12 | SS | 434.8 |

4616 Von Phul St., Sample location 6.
View looking east from Von Phul and
Obear St.

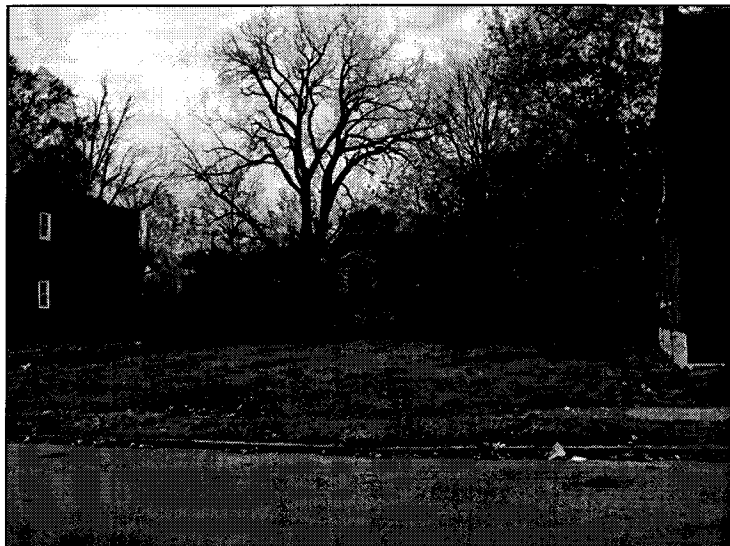
Photograph 16

| TABLE 2. XRF RESULTS FOR SOIL SAMPLES COLLECTED NOVEMBER 16 AND 17, 2004 M. HOLTZMAN METAL CO., ST. LOUIS, MISSOURI | | | | |
|--|---|---|---|---|
| | HWP040058 | HLOT09V02SS16 | SS | 557.8 |

1907 - 1911 Desoto St., Sample location
9. View looking north from Desoto St.
